Manhole Inspection Summary

Manhole # S31SS_026MH

Insp Date: **5/14/07 1:16 PM**

Location Address: **219 LORAIN AVE**

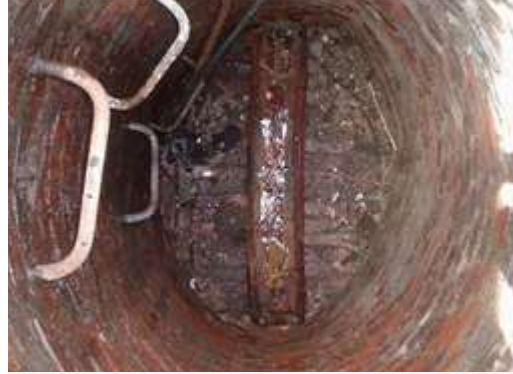
Top View

Corroded steps. Evidence of surcharge - Bench debris.

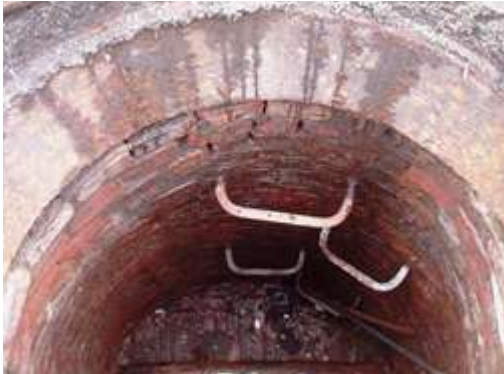
Defect

Frame leaks. Adjustment deterioration and infiltration. Corbel and Barrel infiltration.

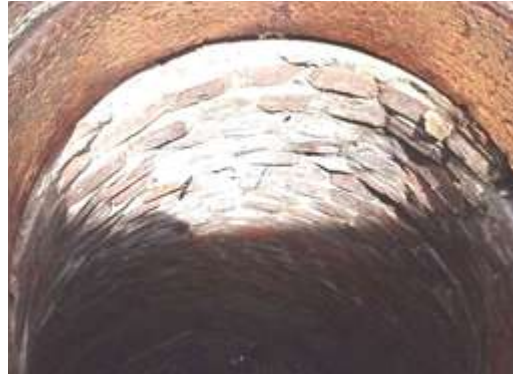
Defect

Adjustment deterioration and infiltration. Corbel and Barrel infiltration - other side.

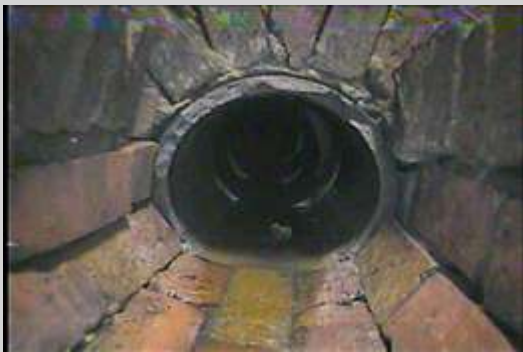
8 in. Circular Gravity Sewer Pipe Out @ 12 O'Clock

Channel deterioration.

Infiltration: **None** Pipe Seal Cond: **Broken**

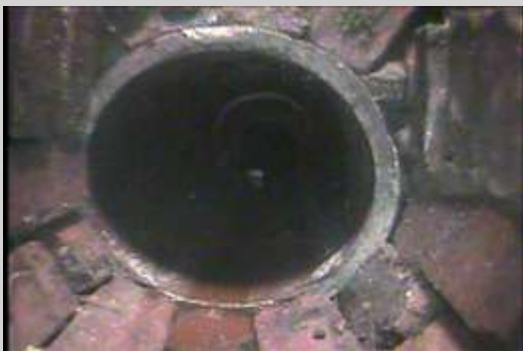
8 in. Circular Gravity Sewer Pipe In @ 6 O'Clock

Channel deterioration.

Infiltration: **None** Pipe Seal Cond: **Broken**
